Manhole Inspection Summary

Manhole # S31WW_008MH

Location Address: **3122 REMINGTON AVE**

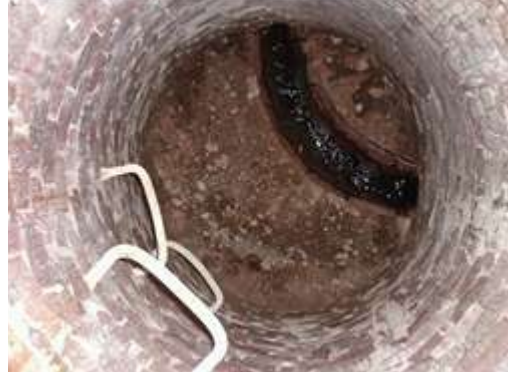
Top View

Bench debris.

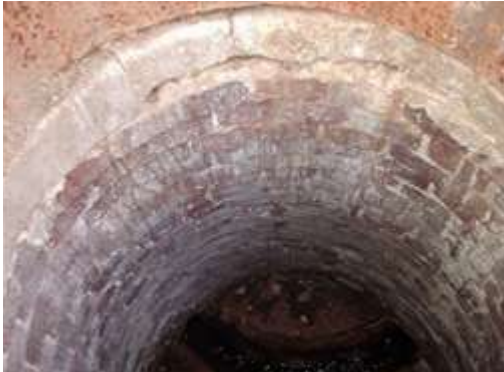
Defect

Condition: ☐ Sound ☐ Cracked ☐ Root Intrusion ☐ Loose Brick ☒ **Deteriorated**

Infiltration: ☐ None ☒ **Joint** ☐ Cracks ☐ Mortar ☐ Roots ☒ **Wall**

Infiltration: ☐ None ☐ Joint ☐ Cracks ☐ Mortar ☐ Roots ☒ **Wall**

Adjustment deterioration and infiltration.
Barrel infiltration - other side.

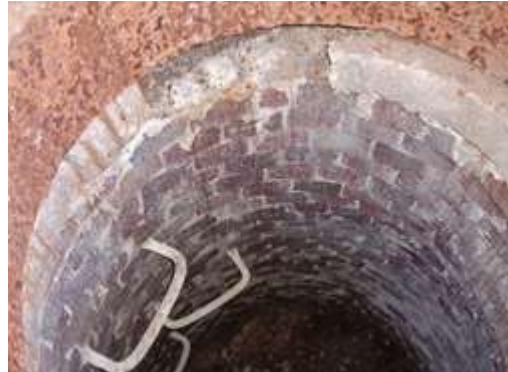
Defect

Adjustment deterioration and infiltration.
Barrel infiltration.
